Uniform Mitigation Verification Inspection Form

Inspection Date: 11/19/2019		
Owner Information		
Owner Name: Pelican Landing		Contact Person:
Address: 2700 N. Beach Rd. (bldg A)		Home Phone:
City: Englewood	Zip: 34223	Work Phone:
County: Charlotte		Cell Phone:
Insurance Company:		Policy #:
Year of Home: 1981	# of Stories: 3	Email:

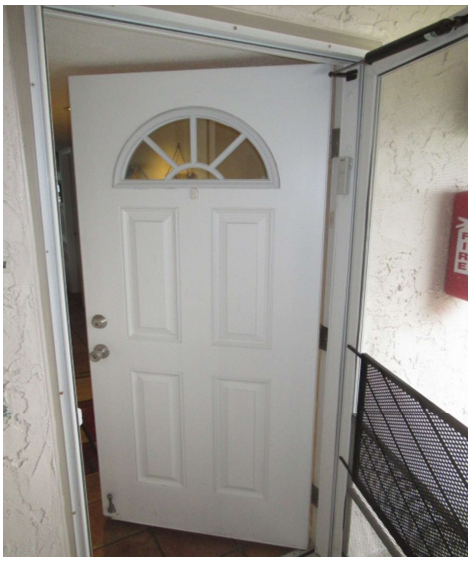
Bldg A

Front doors of all units in the building meet the impact standard

Rated wind screen protects window in every front door in the building

Wind screen hardware, on each side of door

All stand-alone windows in the building meet the large missile impact standard (Keep Safe glass - maximum)

Some rear sliders are unprotected
